Automotive Division Safety Recall "XA" October 24, 2014
Technical Service Bulletin Body Electrical Bulletin No. TS 14 10244

SUBJECT: Safety Recall Campaign "XA";

Headlamp Switch or Daytime Running Light (DRL) Module Overheating

MODEL(S): Forenza (RQ420), Reno (RQ420)

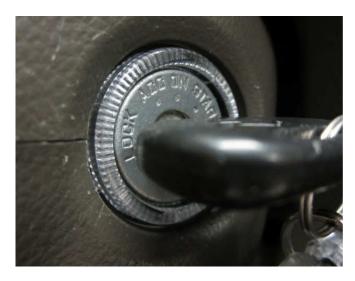
2. Disconnect the battery negative (-) cable and wait at least 90 seconds before proceeding.

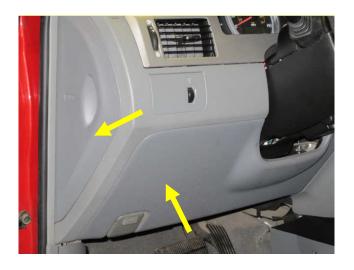
3. Remove the instrument panel side cover and under cover.

4. Remove the two left side front door trim pieces.

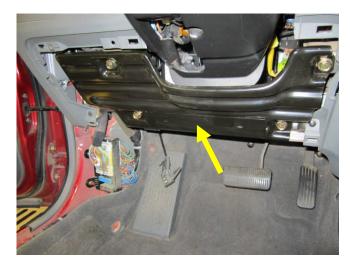
5. Remove the metal knee bolster located behind the under cover.

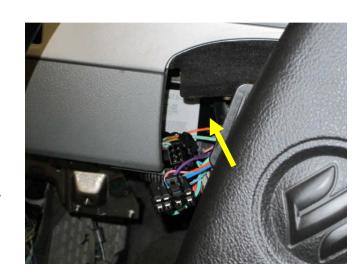
Route the Relay Harness (included in the Parts Kit) through the space that is left of the steering column and down toward the floor. Keep enough harness length at the Signal Switch mounting area to work with.

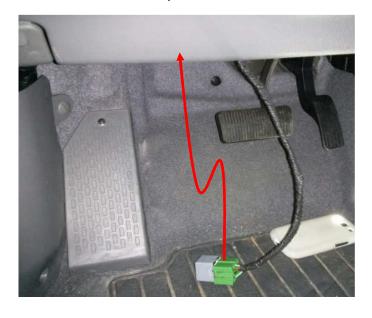
9. Secure the Relay Harness (connector side with the relay attached) to a vacant relay slot behind the under panel.

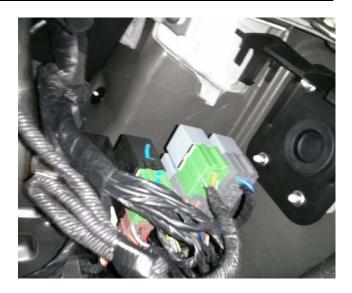
10. Bundle and secure the extra length of Relay Harness behind the Instrument Panel Under Cover in a manner for safe and unobstructed vehicle operation.

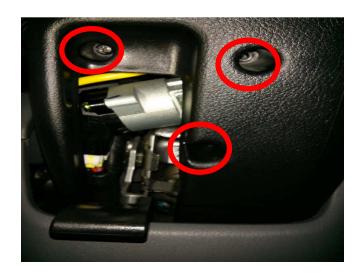
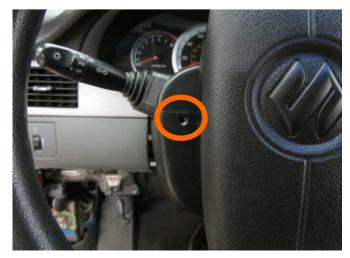
11. Install the upper and the lower steering column covers.

Tighten the 3 lower cover screws to 2.5 N-m (22 lb-in)

Only tighten the 2 screws behind the steering wheel securely; there is no recommended torque value.

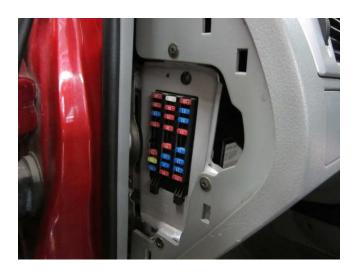
12. Secure the fuse box back into place if removed.

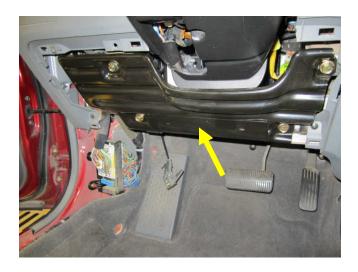
13. Secure the metal knee bolster located behind the under cover.

Torque: 10 N-m (89 lb-in)

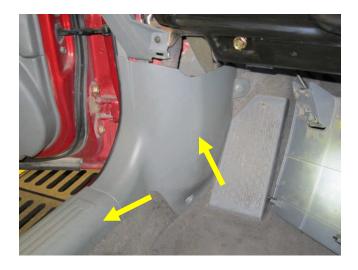
14. Secure the two left side front door trim pieces.

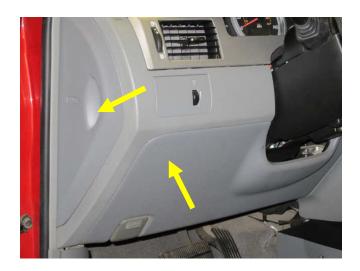
15. Secure the instrument panel side cover and under cover.
